# Athens to Amsterdam

Rescuing a Vintage BMW Motorcycle in 1991

**Derrick King**

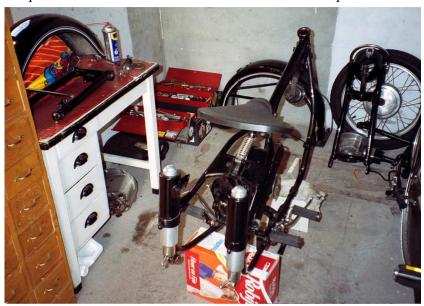
All the steering, suspension, and wheel bearings had to be replaced. The front and rear swingarms had been repainted while the bearing races were still mounted inside them, so that all four suspension bearings were full of rust and paint and incredibly worn. Here is one of them:

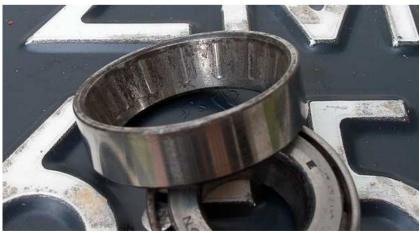
The right rear suspension bearing had several millimeters of the outer race milled away in a half-moon shape by the drive shaft.

Both steering head bearings were worn out. The steering lock was from a Puch moped; it was too long and dragged on the steering column, making the steering stiff on one side. It had to be replaced. One front shock absorber had no damping at all so I replaced all four shock absorbers with brand new, and expensive, Koni units.
